FEEDWATER: WELL WATER

APPLICATION: MUNICIPAL

REVIEW

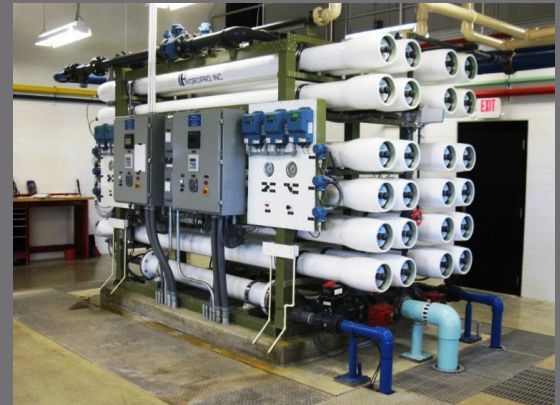
Figure 1. Image of reverse osmosis system at the municipal water plant

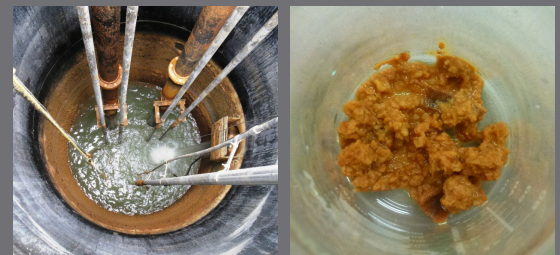
Our applications specialist went to the site and conducted a system audit. After the audit, a tail element from the second stage was removed. During the membrane removal process, an orange foulant on the scroll end of the element (Figure 2, right) was discovered. A sample of the orange granular material was collected and returned to Avista for analysis. The sample was analyzed at the Avista lab and was identified as calcium sulfate scale combined with iron (Figure 3).

Figure 2. Images of the transfer well (left) and scale sample removed from the second stage vessel (right). A sample of the orange granular material from the second stage vessel was collected and returned to Avista lab for analysis. The sample was analyzed and identified as calcium sulfate scale combined with iron. (Figure 2)

A water analysis was requested and entered into a saturation calculation program used to predict the scaling potential of brine streams called Advisor™. The program predicted sulfate (calcium, barium and strontium sulfate) as the primary scale and calcium carbonate as the secondary scale. Several Avista antiscalant products were examined to determine the best product for inhibiting both scales. Based on the saturation levels, the amount of product required and sulfate scale inhibition properties required, the antiscalant Vitec® 7000 was specified for this site. Vitec 7000 was placed online at a dose of 2.0 ppm. Normalized data had not been collected so the Avista application specialist assisted the plant in developing a procedure to collect, normalize and analyze data periodically to ensure the plant was running at peak performance.

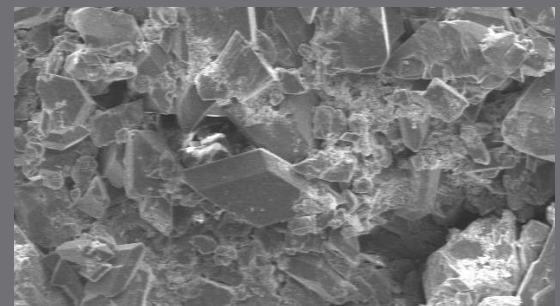
Element	Weight Percentage
Carbon	3.96
Oxygen	56.48
Silicon	0.41
Sulfur	15.26
Calcium	20.63
Iron	3.26

Figure 3. Scanning Electron Microscopy image of the sample removed from the second stage vessel showing distinct calcium sulfate crystals (top). Energy Dispersive X-ray confirms calcium sulfate and iron were the main components in the foulant.

Analytical methods and onsite troubleshooting identified the cause for the rapid fouling of the RO system as calcium sulfate scaling in the second stage. In order to control the scaling events, the use of an antiscalant specifically formulated to control sulfate scales as well as calcium carbonate was implemented. The application and use of Vitec 7000 has stabilized the RO system performance and the plant has been running two years without cleaning.

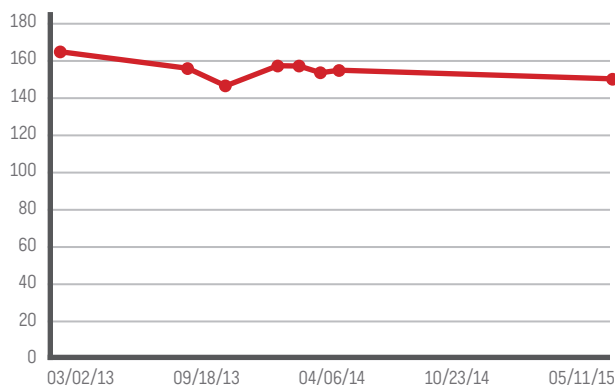
**Normalized Permeate Flow—First Stage**

- 1 Only an 8.0% decrease in flow was observed in the first stage over 2 years (Figure 4).
- 2 The second stage of the RO system showed less than a 5% loss of permeate flow over the same 2 years (Figure 5).

Figure 4. Normalized permeate flow of the first stage of the RO system after Vitec 7000 was put online

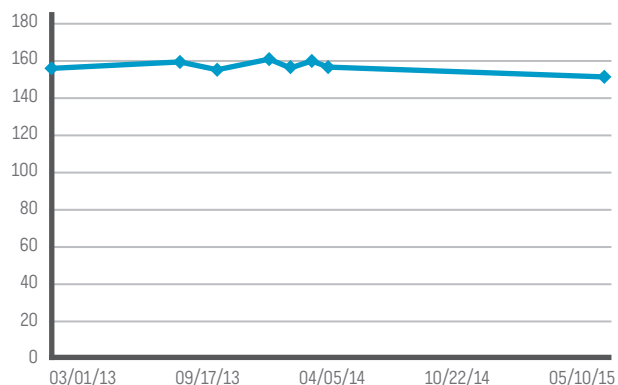
**Normalized Permeate Flow—Second Stage**

Figure 5. Normalized permeate flow of the second stage of the RO system after Vitec 7000 was put online

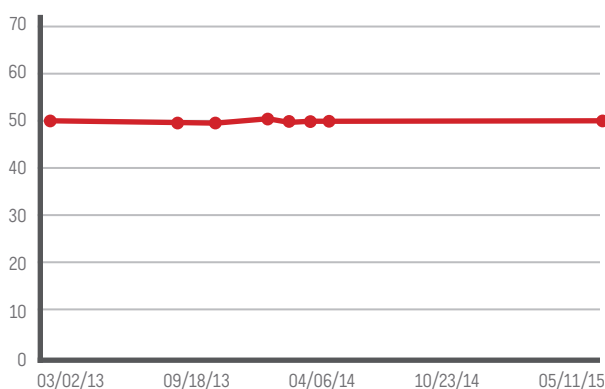
**Normalized Delta Pressure—First Stage**

- 3 The delta pressures remained constant (Figures 6 and 7).

Figure 6. Normalized delta pressure of the first stage of the RO system after Vitec 7000 was put online

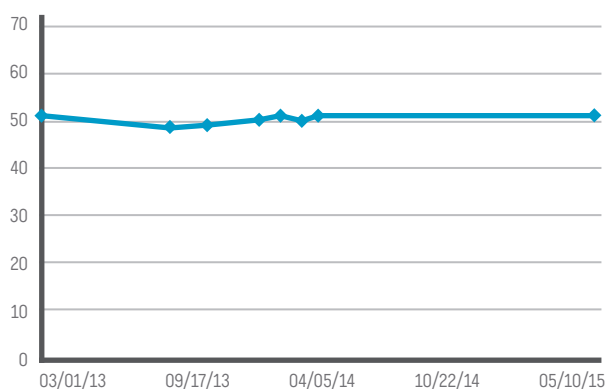
**Normalized Delta Pressure—Second Stage**

Figure 7. Normalized delta pressure of the second stage of the RO system after Vitec 7000 was put online
