Re-evaluate Plant Systems to Optimize Membrane Performance

Reduced groundwater levels from drought, seasonal changes, and excessive pumping poses significant challenges for membrane water treatment plants across California. Review system readiness to identify concerns before fouling events occur.

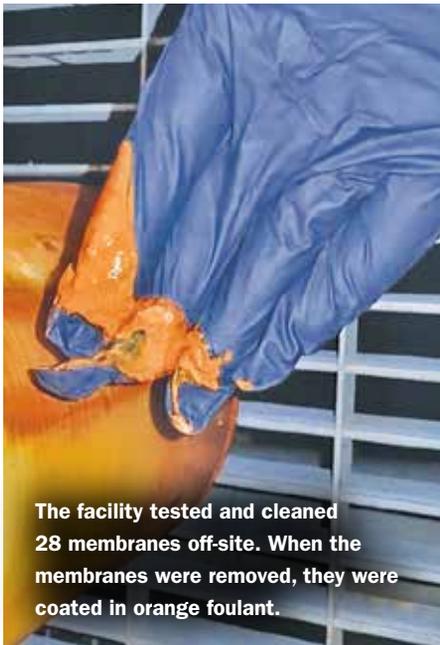
The facility tested and cleaned 28 membranes off-site. When the membranes were removed, they were coated in orange foulant.

Off-site, 28 membranes were tested and cleaned, by position, to validate the recommended specialty cleaner and better predict the outcome of a full-scale cleaning. This strategy minimized the risk of membrane damage and rejection loss while testing the efficacy of the cleaning chemical on a full element. When the membranes were removed, they were coated in orange foulant (Figure 4), confirming the results of the lead and tail autopsies performed.

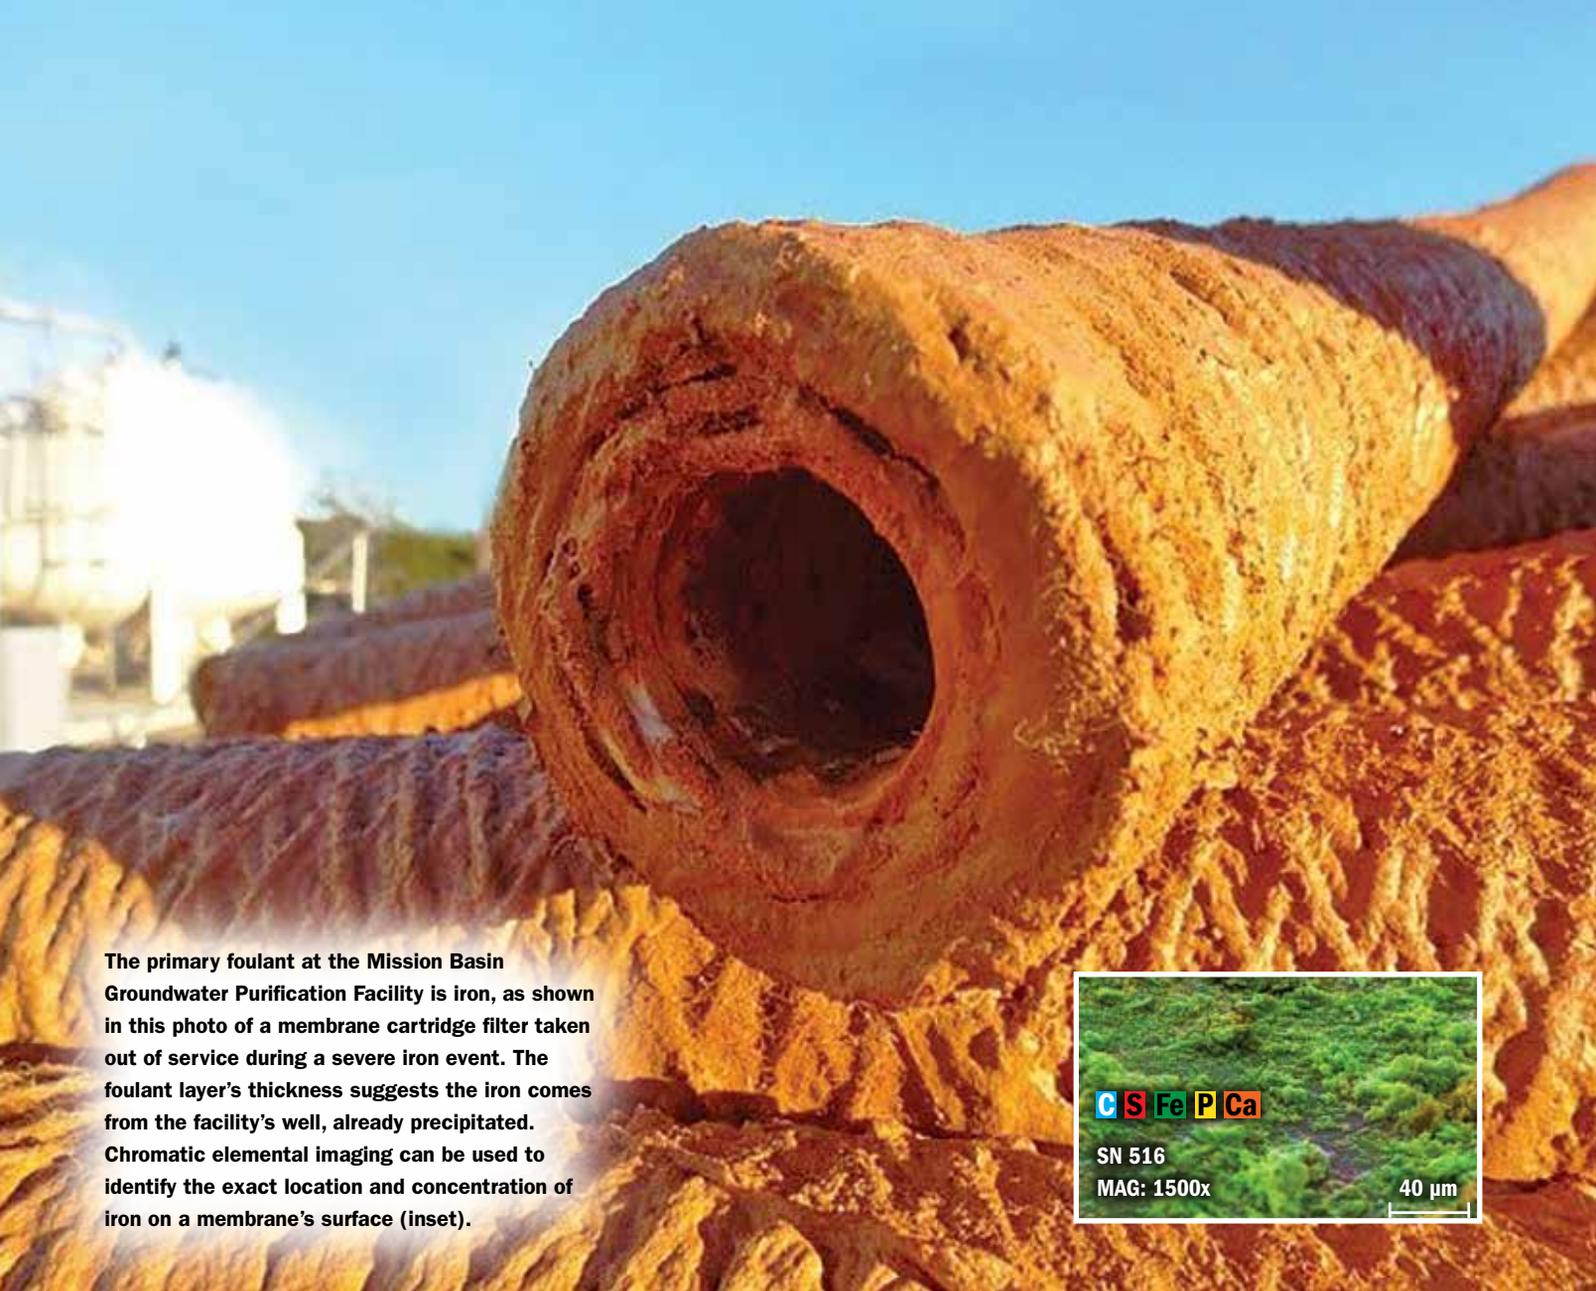
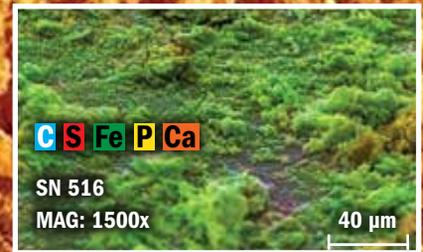
The primary foulant at the Mission Basin Groundwater Purification Facility is iron, as shown in this photo of a membrane cartridge filter taken out of service during a severe iron event. The foulant layer's thickness suggests the iron comes from the facility's well, already precipitated. Chromatic elemental imaging can be used to identify the exact location and concentration of iron on a membrane's surface (inset).

Partnering with a local chemical supplier and RO process expert, two membrane autopsies were conducted using the first-stage lead and second-stage tail to identify fouling differences across the system. The analysis revealed that iron was the primary foulant, as seen in a physical inspection in

which the membrane surface was visibly coated with an orange foulant.

Further autopsy analysis using a high-resolution image identified the exact location and concentration of the iron on the foulant sample. The image showed a relatively thick and even iron layer, confirming that iron was the main foulant on both the lead and tail positions and that a specialty iron cleaner was required for an optimal clean.

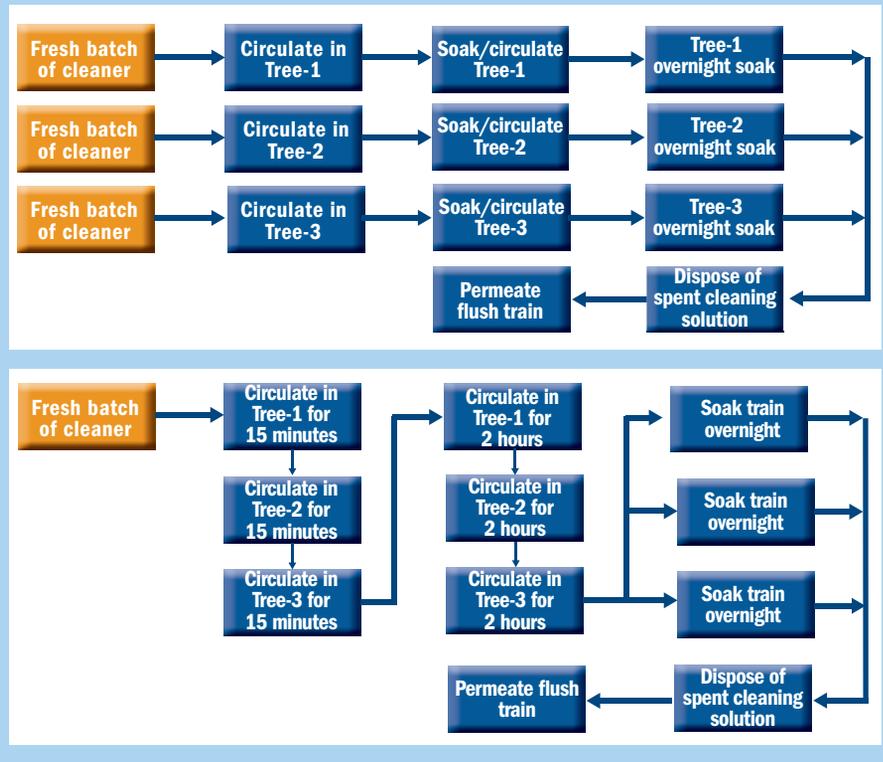
Figures 1 and 2. Evolving Cleaning Procedures

The top figure shows a new cleaning procedure based on the results of single-element testing.

The bottom figure shows an optimized cleaning approach based on a post-clean review.

Based on the historical protocol review, as well as the results of the single-element testing and recommendation of a new specialty iron cleaner, a different cleaning procedure was drafted (Figure 1). The procedure consisted of using a single low-pH cleaner at a 2 percent concentration by weight. The cleaner was batched between trees, recirculated, and soaked overnight to give the system the contact time recommended in the single-element cleaning study.

downtime and cleaning-chemical costs further, but the process is labor intensive. Given the fact a tree couldn't be fully isolated, it was determined the entire train could be cleaned with a single batch of cleaner. Figure 2 shows the improved cleaning procedure, resulting in similar performance enhancements as cleaning the single train and batching chemical in between trees. The cleaning consisted of a single batch at a 2 percent strength by weight of the low pH cleaner. The cleaning solution was recirculated through each tree for varying amounts of time. As a tree was recirculated, the other two were soaking. This further optimized cleaning, reducing cleaning time and downtime to approximately a day.
